PREPARED FOR
Big Trout Condominium Association
Board of Directors
c/o
Greenstone Homes
1421 N. Meadowwood Lane, Suite 200
Liberty Lake, WA 99019

Capital Asset Replacement Reserve Study BIG TROUT CONDOMINIUM

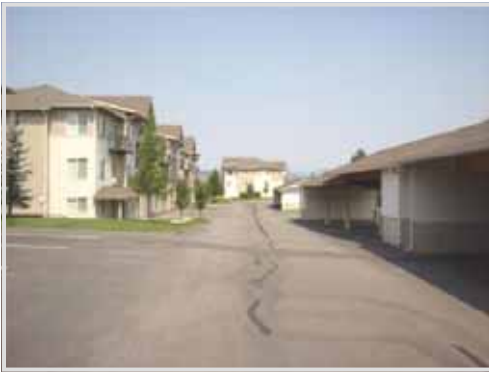
Reserves will be set aside for the 2036 overlay event

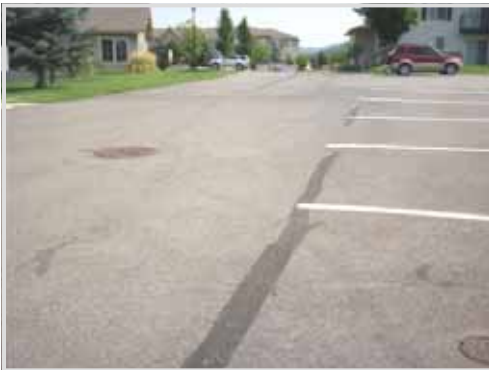
Repairs and sealcoating are scheduled on a six-year cycle

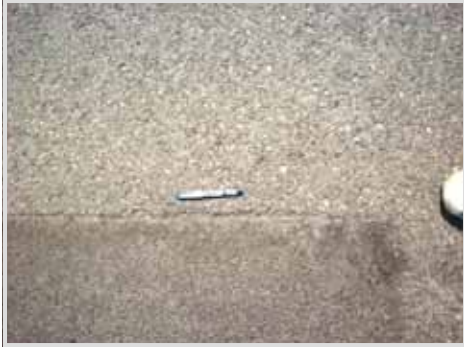
We recommend an annual review of the asphalt in the spring.

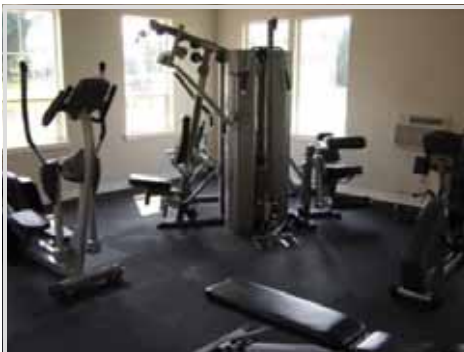
The majority of the fitness equipment will last between five and fifteen years.

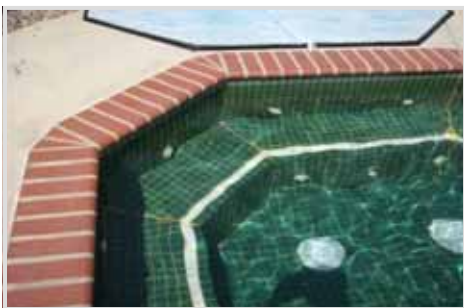
The spa (above) will need to be resurfaced in approximately 10 to 12 years

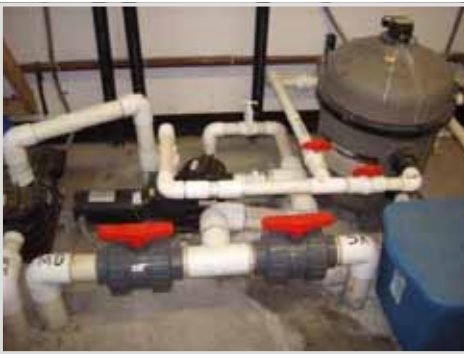
The pool pumps, filters, motor and heater are all well maintained throughout both the Winter and Summer months

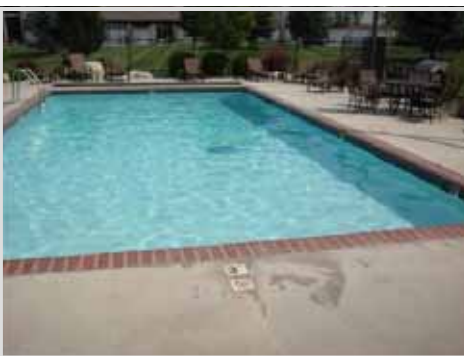
The pool walls will generally need to be re-plastered every 15 to 20 years

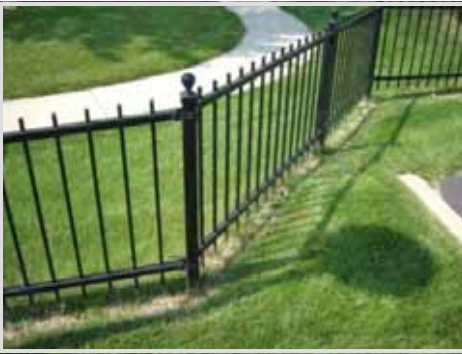
The perimeter fence that runs along the property line between the two developments is the responsibility of the Association

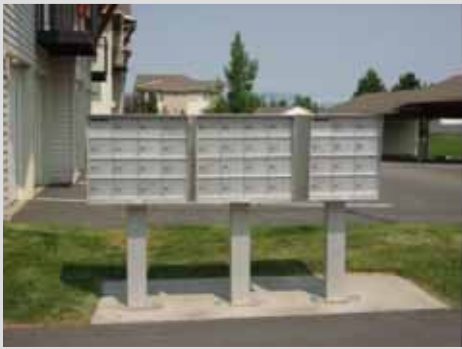
We have scheduled the replacement of the mail boxes in 17 years

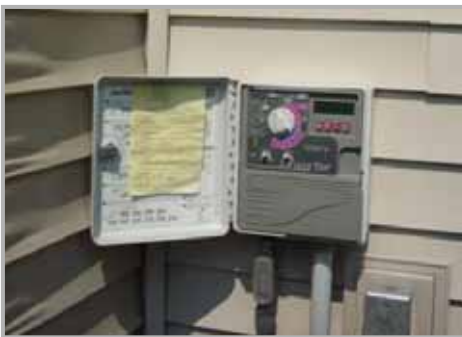
The Rain Bird® electronic times will require replacement at approximately 8-year intervals.

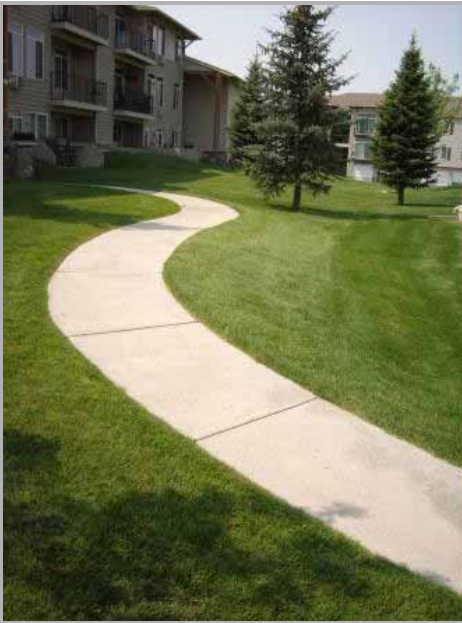
Landscaping appears to be of a good standard and we would recommend the Association continue with their current program of maintenance..

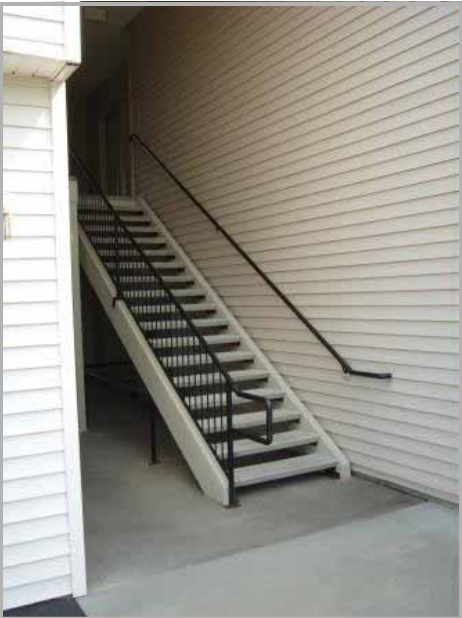
Periodic repairs to concrete walks and the concrete stair treads will be required in the future.

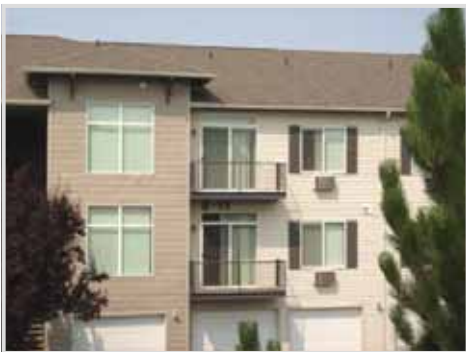
Ongoing replacement of the vinyl has been anticipated to occur over the 30-year projection period.

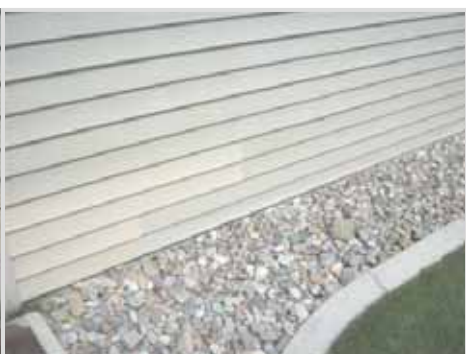
An example of limited repairs which gives a "patched" appearance to the building.

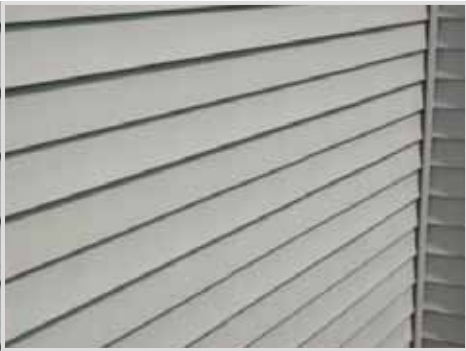
The buildings should be washed at least every two-years

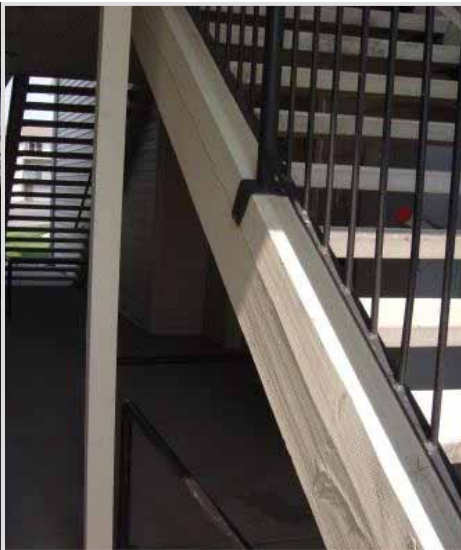
The complete replacement of the vinyl siding has been anticipated to occur in 2041

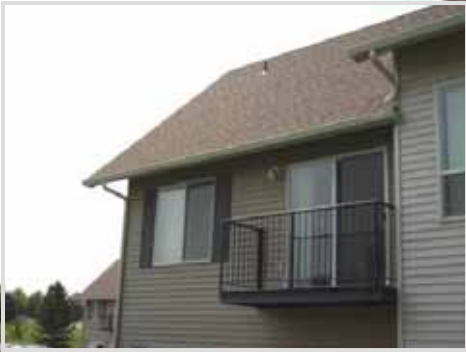
Replacement of the current roof is scheduled for 2026.

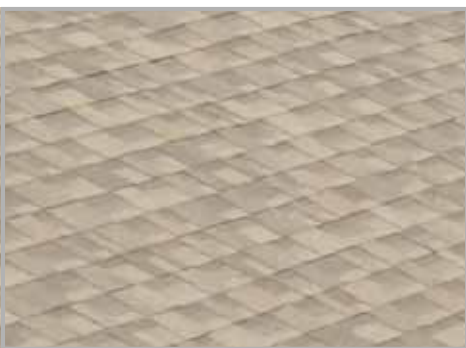
Basic maintenance is important to extend the life of the roofing

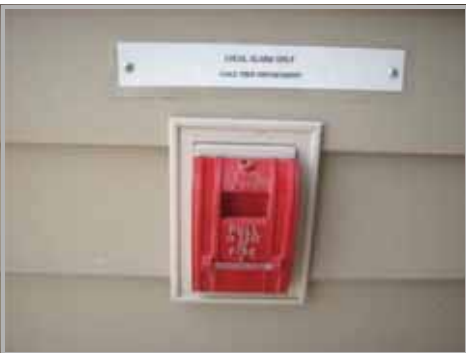
Pull stations are located in the breezeways of the each three story buildings.

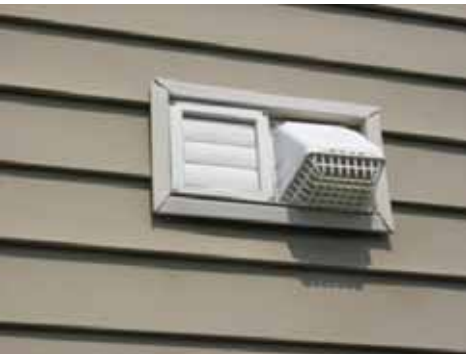
Dryer vents should be cleaned every 2-4 years as part of regular maintenance.

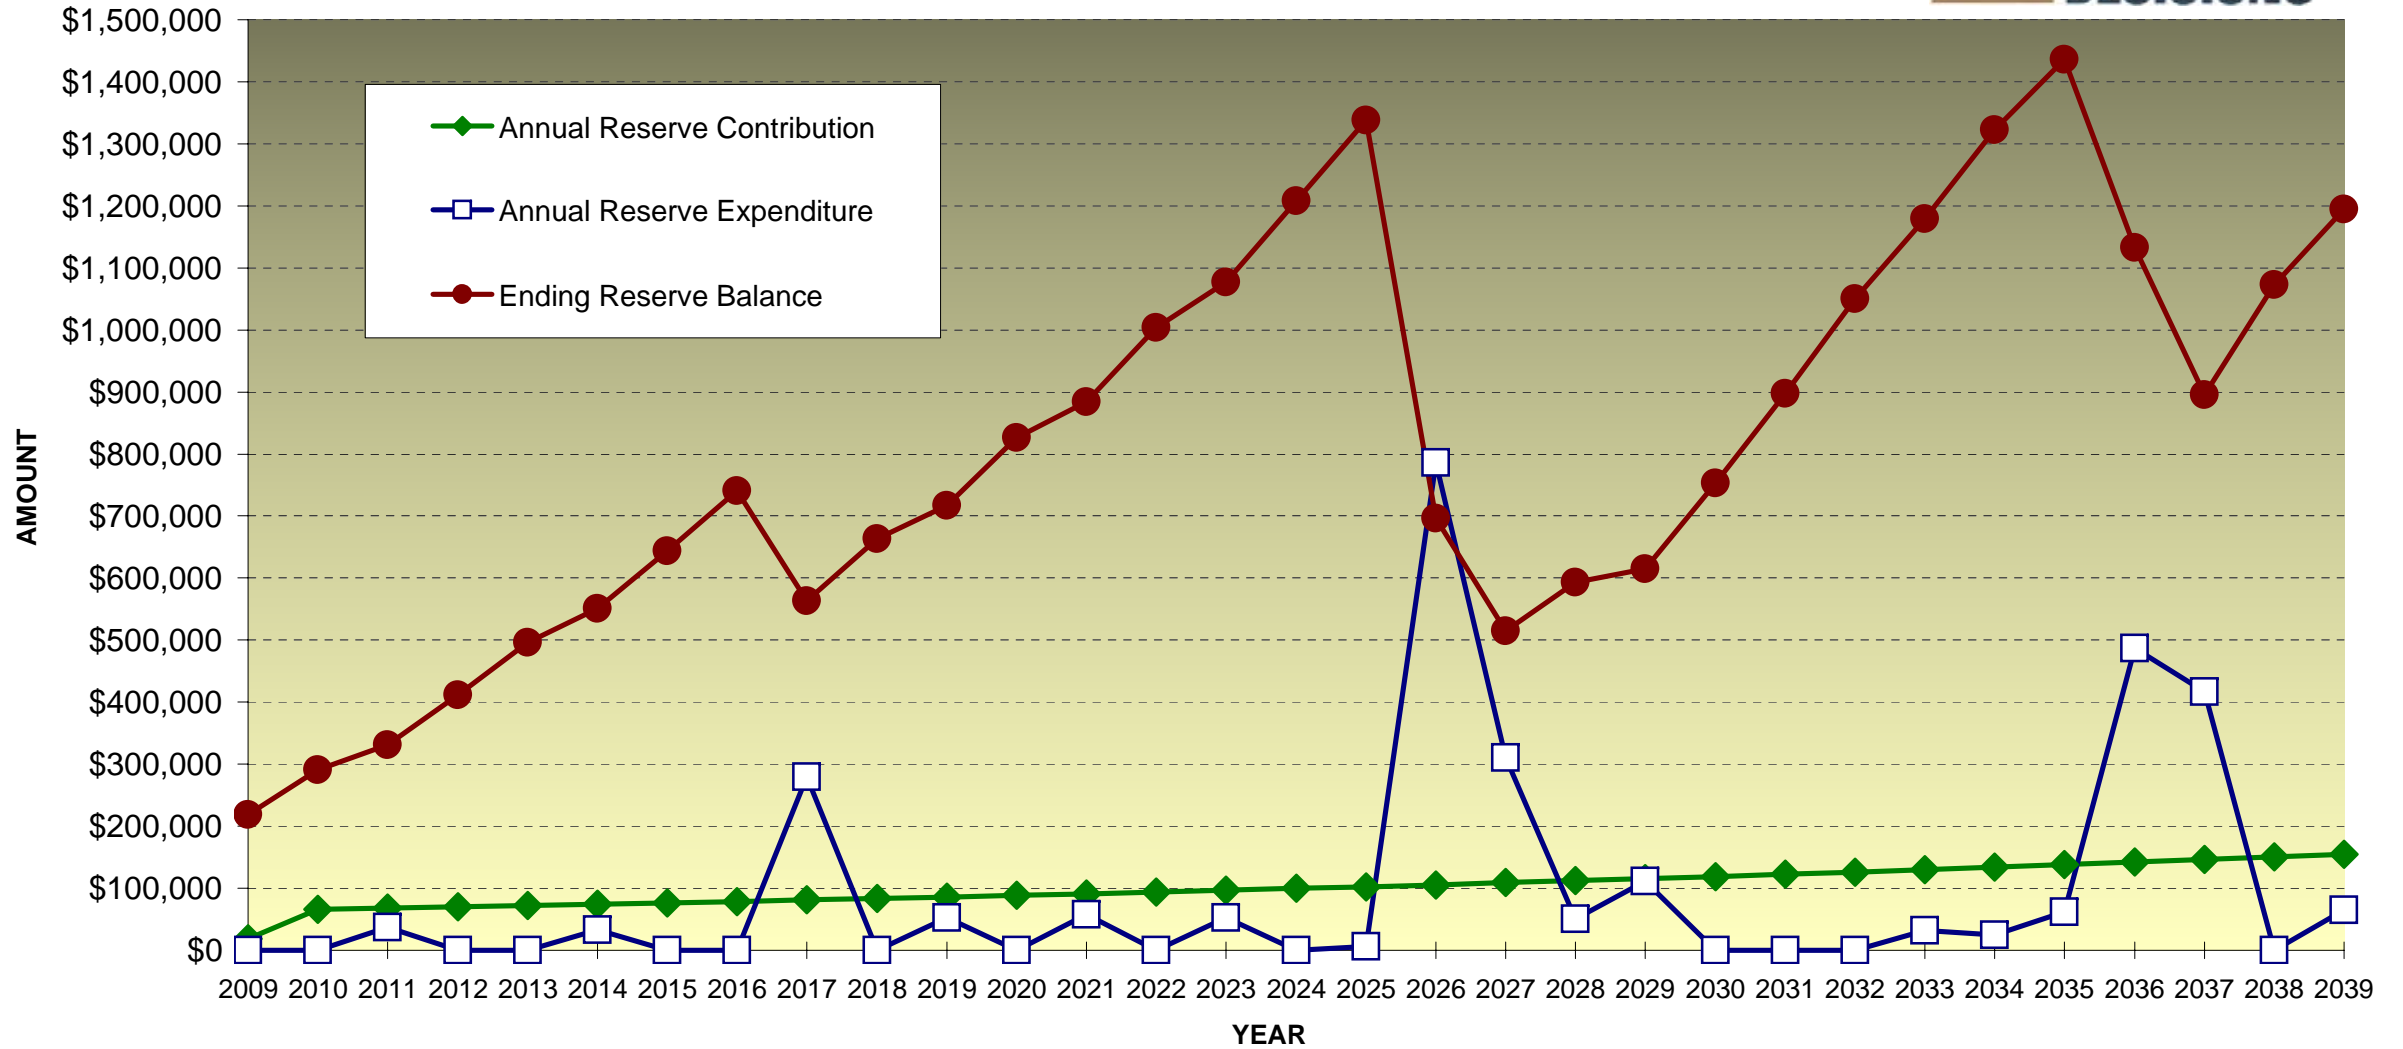
BIG TROUT CONDOMINIUM
