# RESERVE ANALYSIS REPORT

## Big Trout Condominiums

Liberty Lake, Washington

Thursday, March 24, 2022

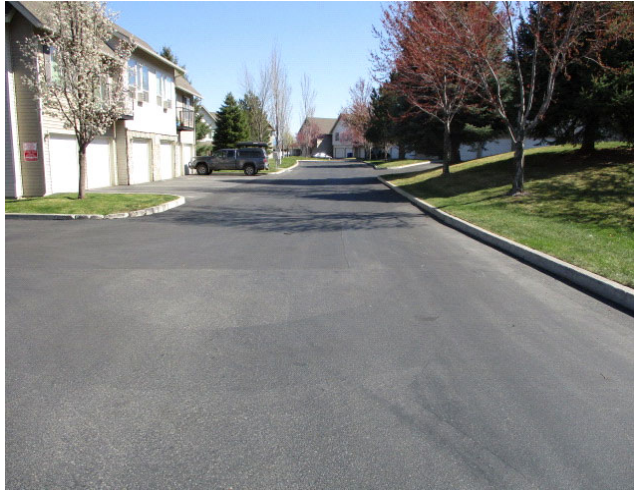
Due to the extensive asphalt repairs performed in 2020, I have extended the asphalt overlay replacement date.

9 - manhole cover adjustments	@	\$340.00	=	\$3,060.00
160,820 - sq. ft. of asphalt overlay	@	\$1.65	=	\$265,353.00
17 - valve cover adjustments	@	\$125.00	=	\$2,125.00
		TOTAL	=	\$270,538.00

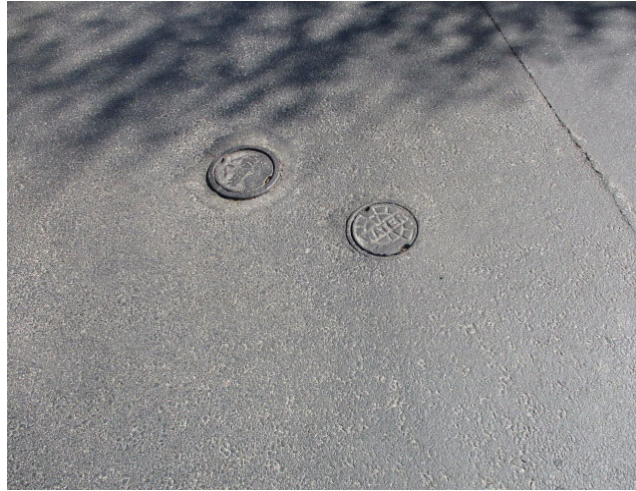
The association had extensive asphalt repairs performed in 2020 at a cost of \$149,634.00.

It is estimated that a percentage of the asphalt areas will require repair or replacement. The actual condition of the asphalt should be monitored through time and these estimates adjusted accordingly.

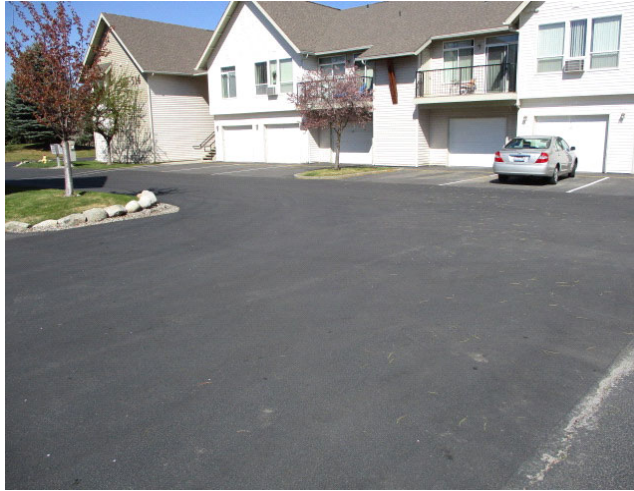
The association had the asphalt seal coated and crack fill in 2020 at a cost of \$29,310.44.

Asphalt surfaces should be seal coated within 5 years of their initial installation. Thereafter, a 3 to 5 year cycle should be observed and adjusted according to the client's particular needs.

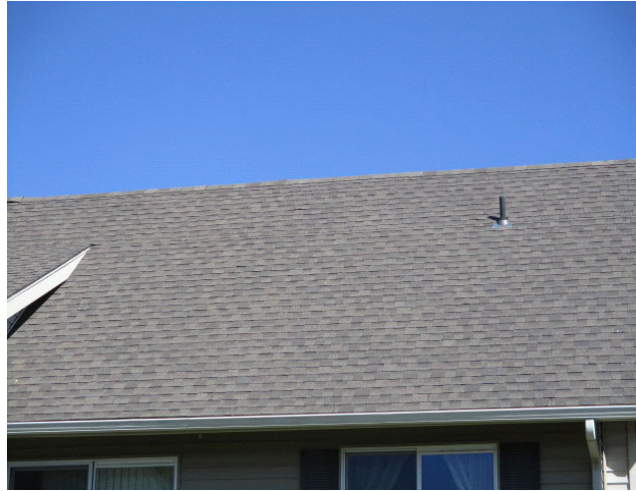
The association had the asphalt roofs located at buildings 15, 16, 18, 21, 22, 23, 30 replaced in 2021 at a cost of \$343,549.32.

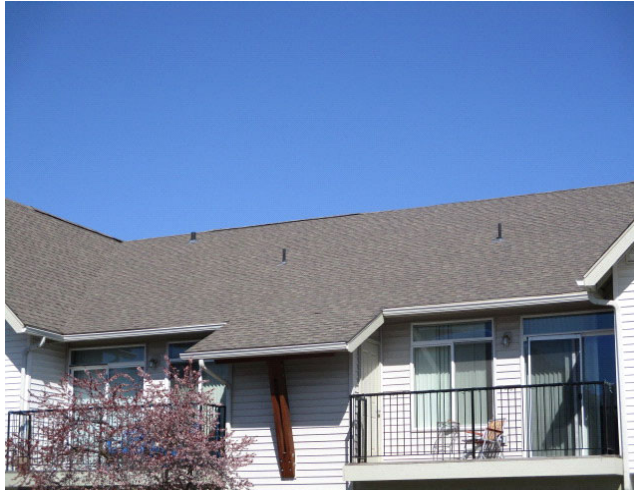
The association is having the the asphalt roofs located at buildings 20, 24, 25, 26, 27, 28, 29 replaced in 2022 at an estimated cost of \$341,318.00.

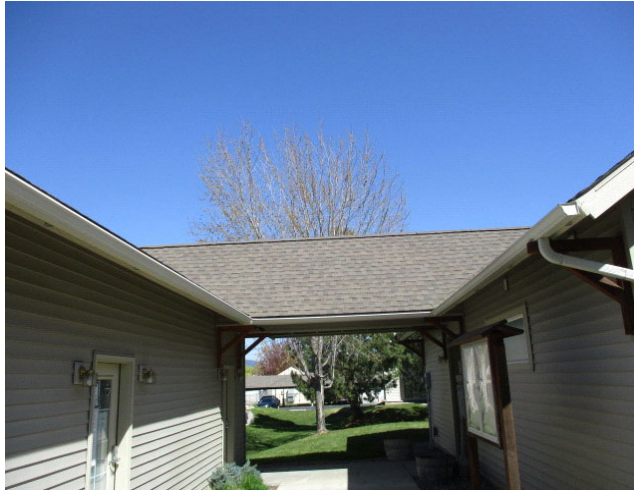
The association is having the the asphalt roofs located at buildings 20, 24, 25, 26, 27, 28, 29 replaced in 2022.

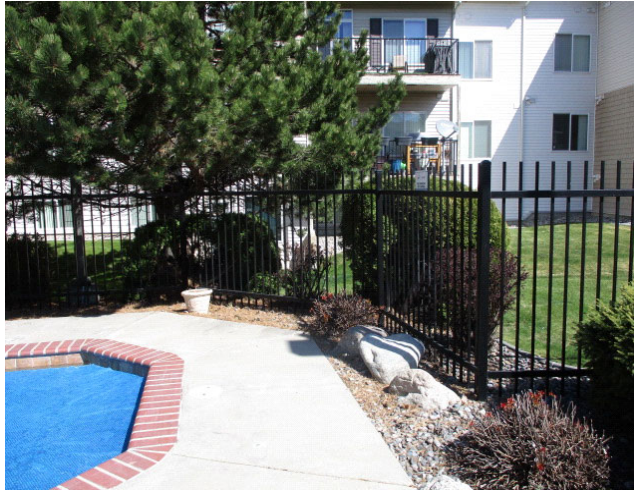
This is for painting of the metal fencing surfaces located throughout the community:

- 5ft pool fencing	1,225 sq. ft.
	1,225 sq. ft.

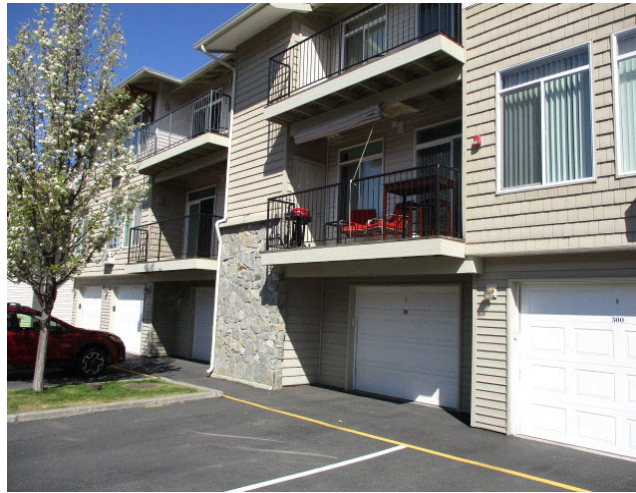
The association had building 23 fully painted and buildings 15, 16, 18, 21, 22, 30 partial painted in 2021 and will be completed in 2022 at a cost of \$82,110.60.

In 2018 the association had the metal deck brackets painted at a cost of \$6,638.00.

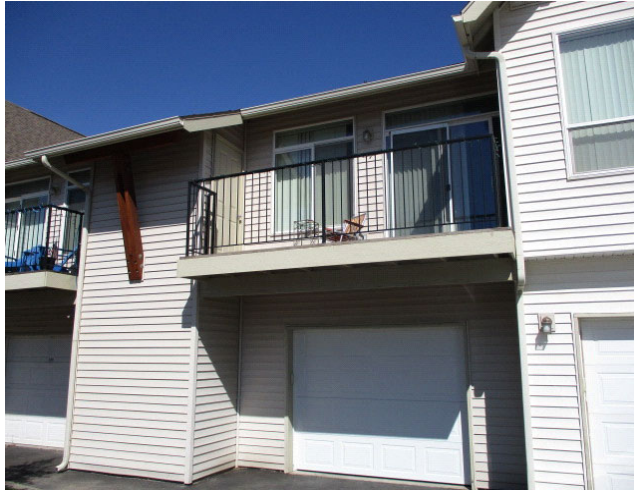
The association is having building 20, 24, 25, 26, 27, 28, 29, carports, fitness center and 15, 16, 18, 21, 22, 30 finish painted in 2022 at an estimated cost of \$215,000.00.

In 2018 the association had the metal deck brackets painted at a cost of \$6,638.00.

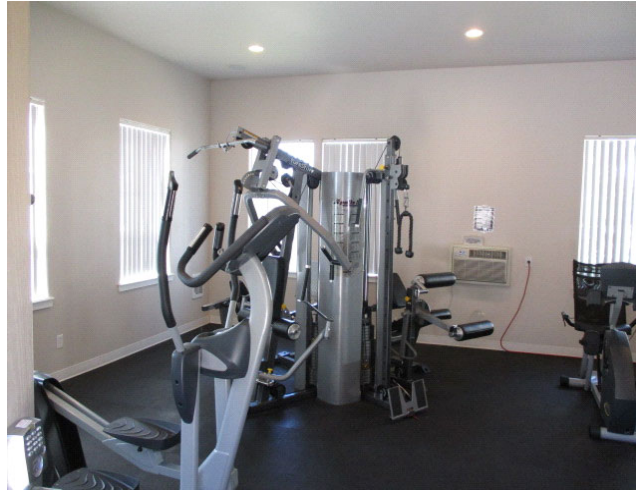
This is for interior painting of the fitness center & pool house.

Paint life cycle is dependent upon the type of material being applied to, surface preparation, quality of paint, site and weather conditions. Repair, replace and re-caulk any damaged siding or trim.

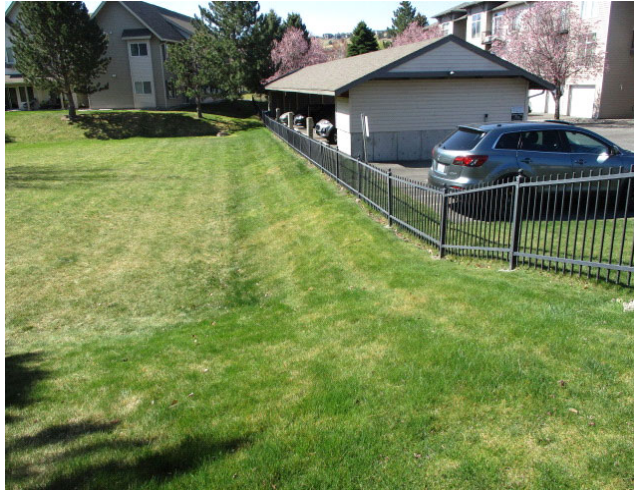
This is for painting of the metal fencing surfaces located throughout the community:

- 3ft property line fencing	4,950 sq. ft.
	<u>4,950 sq. ft.</u>

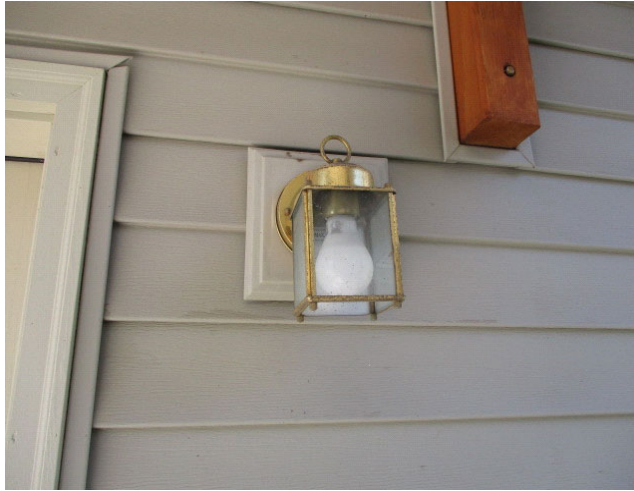
These are the exterior lights located at the fitness/pool house:

10 - porch & patio lights*	@	\$110.00	=	\$1,100.00
1 - sensored flood lights*	@	\$160.00	=	\$160.00
		TOTAL	=	<u>\$1,260.00</u>

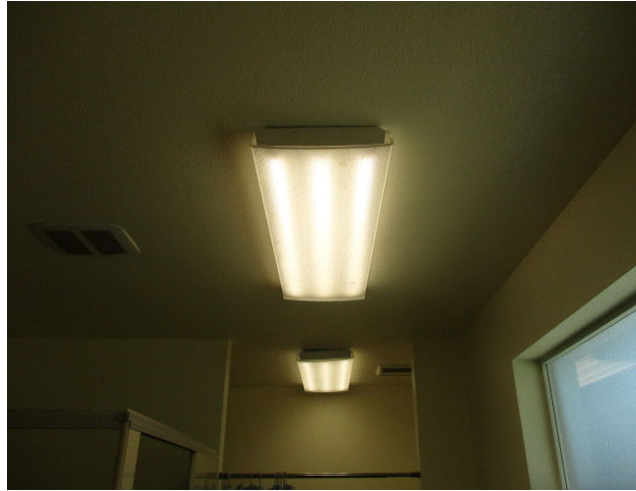
These are the interior lights located at the fitness/pool house:

6 - florecent lights	@	\$120.00	=	\$720.00
		TOTAL	=	\$720.00

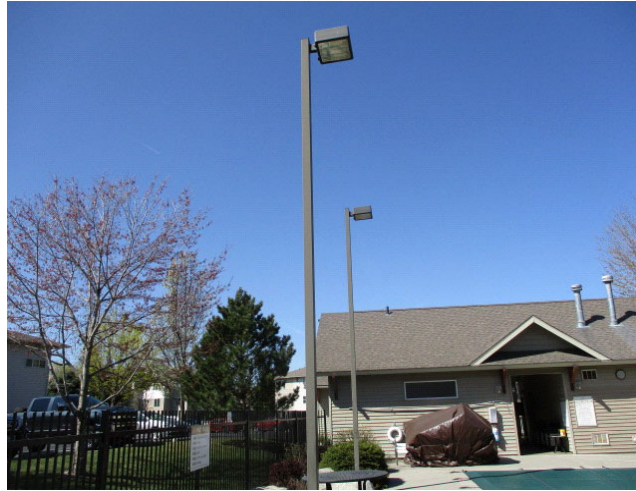
These are the street lights located throughout the community:

13 - metal post street lights*	@	\$1,500.00	=	\$19,500.00
5 - metal post pool lights*	@	\$1,500.00	=	\$7,500.00
		TOTAL	=	<u>\$27,000.00</u>

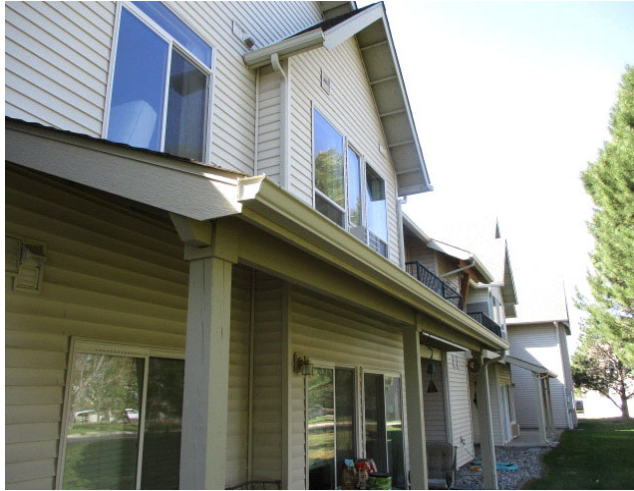
The association had the rain gutters located at buildings 15, 16, 18, 21, 22, 23, 30 replaced in 2021 at a cost of \$61,270.39.

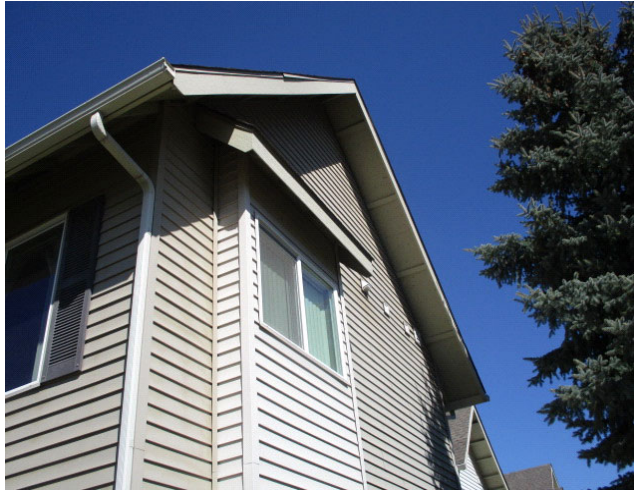
The association is having the rain gutters replaced at buildings 20, 24, 25, 26, 27, 28 and 29 replaced in 2022 at an estimated cost of \$63,432.00.

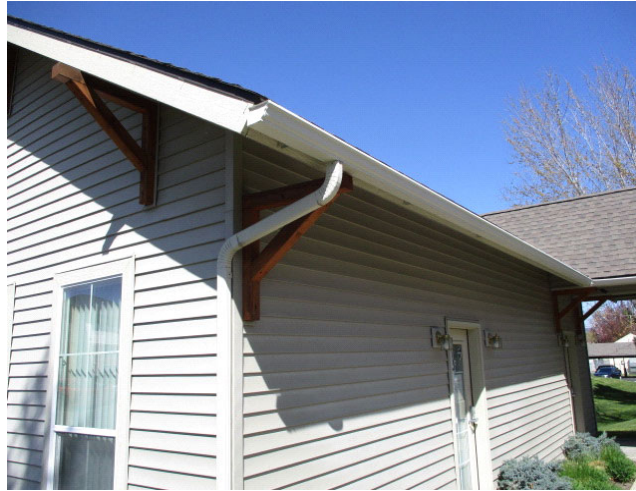
These are the rain gutters located at the fitness center and carports:

670 carports	@	\$14.60	=	\$9,782.00
150 fitness center	@	\$14.60	=	\$2,190.00
		TOTAL	=	<u>\$11,972.00</u>

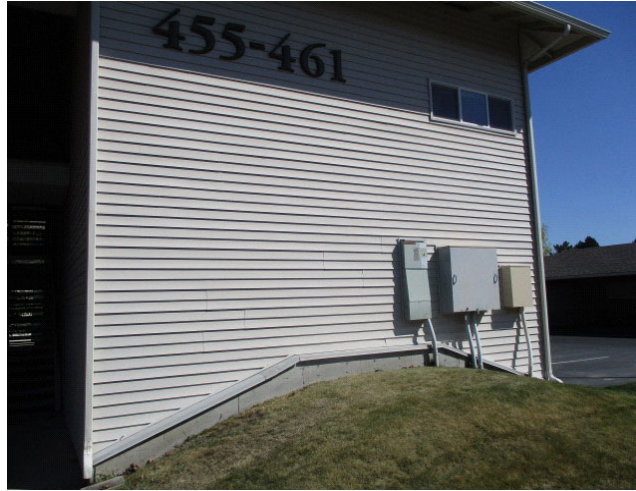
This is for the vinyl siding located throughout the community:

housing buildings	136,160 sq. ft.
fitness center / pool house	2,950 sq. ft.
carports	9,520 sq. ft.
	<u>148,630 sq. ft.</u>

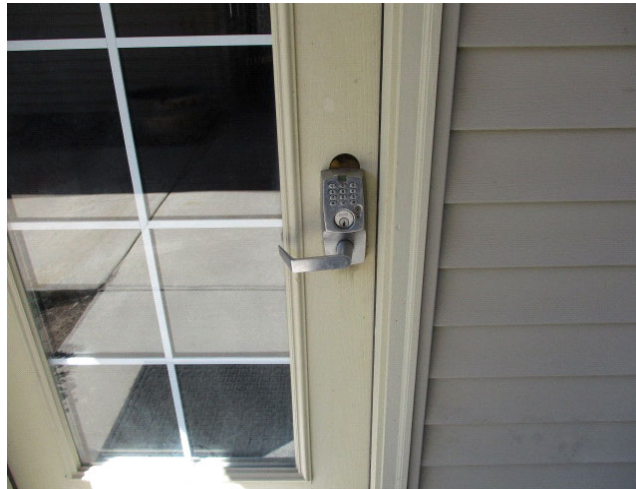
These are the Schlage entry keypads located at the fitness center and pool house.

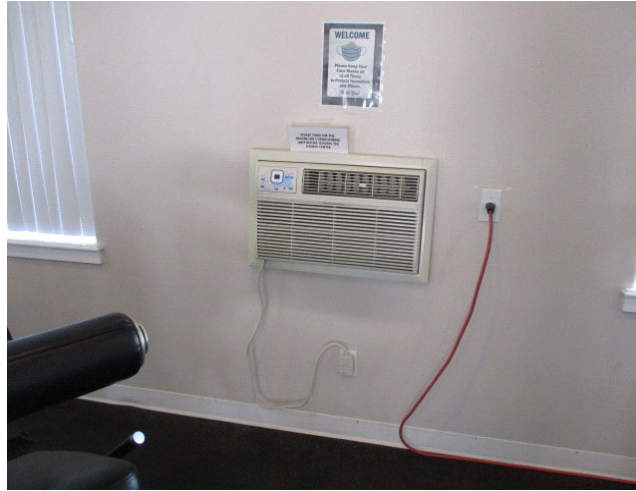
This is the wall mounted Frigidaire Air Conditioner located in the fitness center.

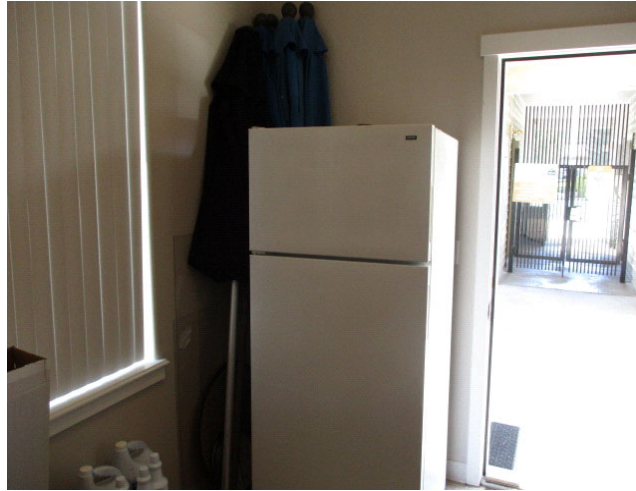
This is the refrigerator located in the fitness center, office/storage room:

1 refrigerator	@	\$800.00	=	\$800.00
		TOTAL	=	\$800.00

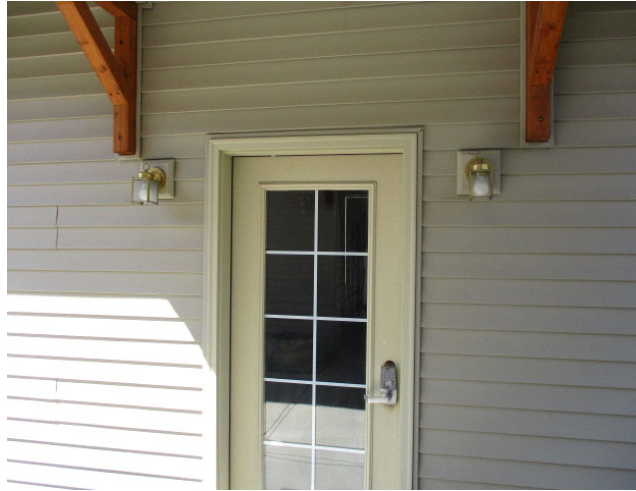
These are the exterior doors located at the fitness center and pool house:

3 - 3' x 6'8" metal doors	@	\$350.00	=	\$1,050.00
2 - 3' x 6'8" fiberglass doors	@	\$600.00	=	\$1,200.00
		TOTAL	=	\$2,250.00

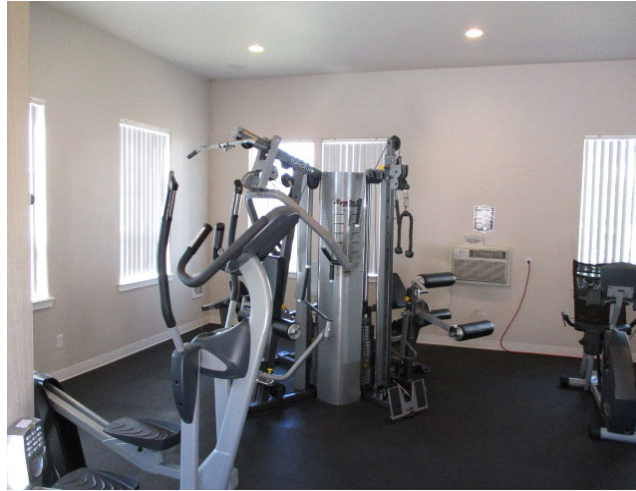
These are the exercise equipment located in the fitness center:

- 1 - Precor EFX534i Elliptical
- 1 - Nautilus NE 3000 Elliptical
- 1 - Sports Art 530R Bike
- 1 - True PS900 Tread Mill
- 1 - Tuff Stuff Apollo 5 Weight Station

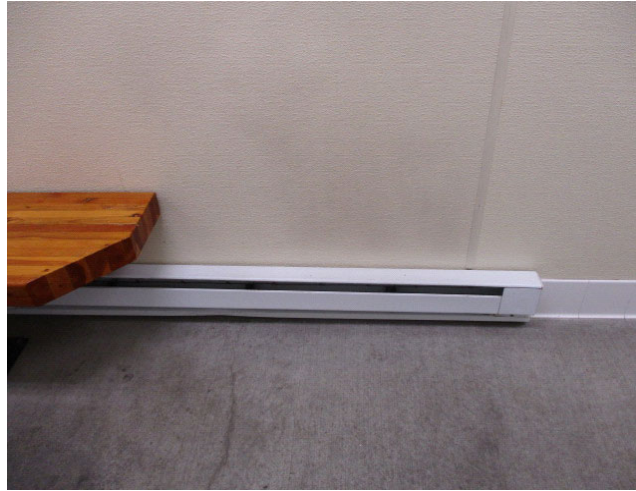
These are the electric heaters located in the fitness center and pool house:

3 - cadet electric heaters	@	\$350.00	=	\$1,050.00
2 - baseboard electric heaters	@	\$300.00	=	\$600.00
		TOTAL	=	\$1,650.00

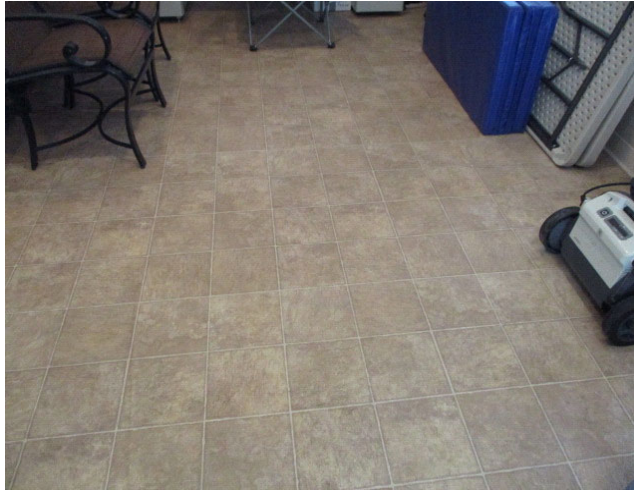
This is the vinyl flooring located at the office/storage in the fitness center.

The remaining life of this component has been extended due to its apparent infrequent use.

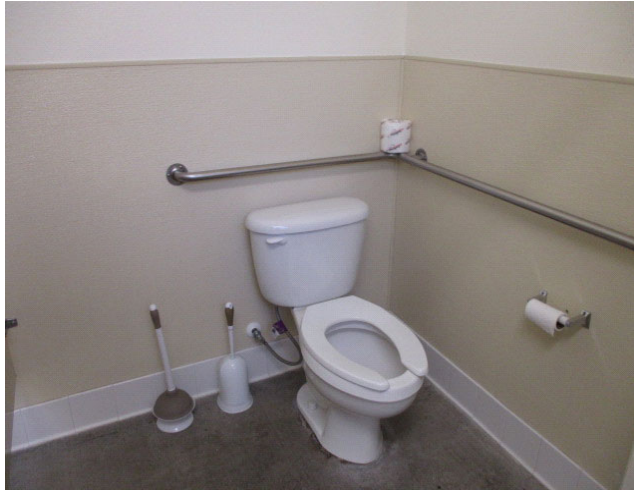
These are the plumbing fixtures located at the pool house restrooms:

2 - toilets, tank type	@	\$525.00	=	\$1,050.00
2 - sinks, wall hung	@	\$550.00	=	\$1,100.00
2 - showers, ada	@	\$2,100.00	=	\$4,200.00
		TOTAL	=	<u>\$6,350.00</u>

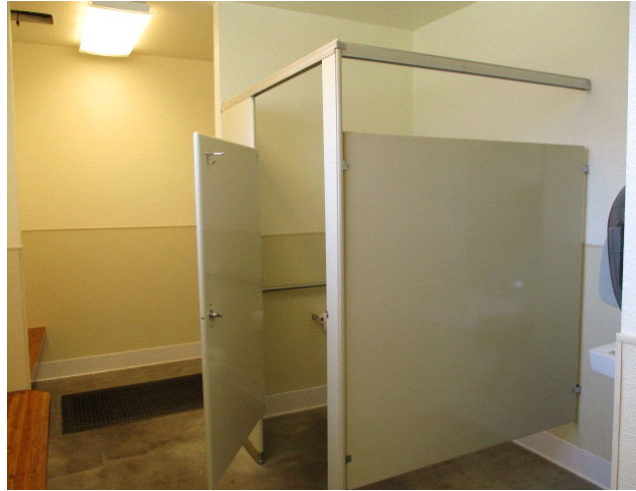
These are restroom partitions located in the pool house:

2 - toilet partitions	@	\$1,300.00	=	\$2,600.00
		TOTAL	=	<u>\$2,600.00</u>

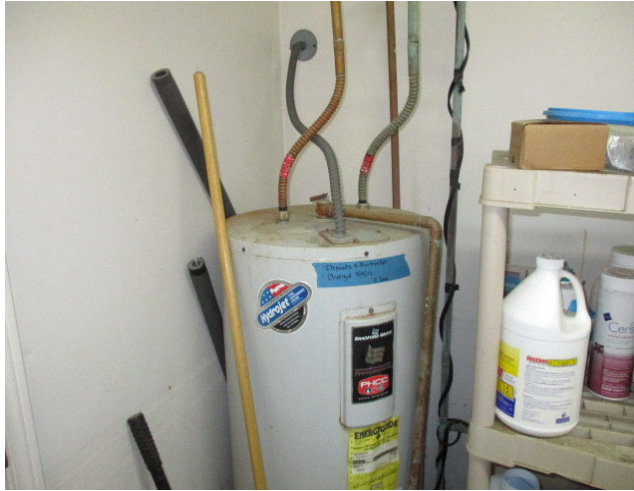
This is the electric water heater located in the pool house mechanical room:

1 - 52 gallon electric water heater	@	\$950.00	=	\$950.00
		TOTAL	=	\$950.00

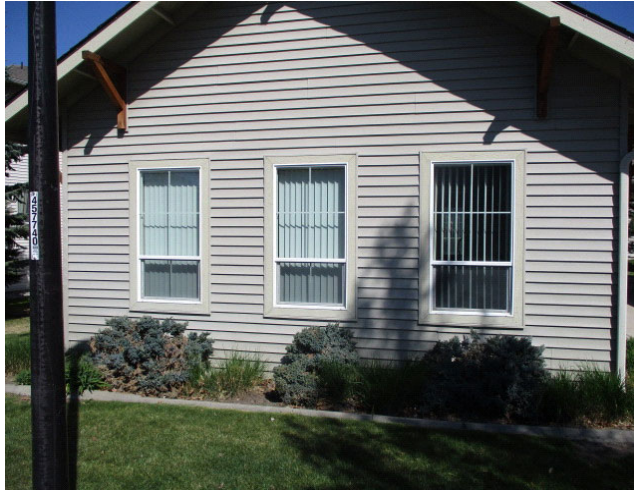
This is for the fitness/pool house windows. Cost is based off of an average of the window dimensions. Labor replacement is included in replacement cost.

Vinyl windows are considered to be a lifetime component if properly installed and maintained. Periodic window inspections and ongoing maintenance may prevent the necessity of a total building window replacement.

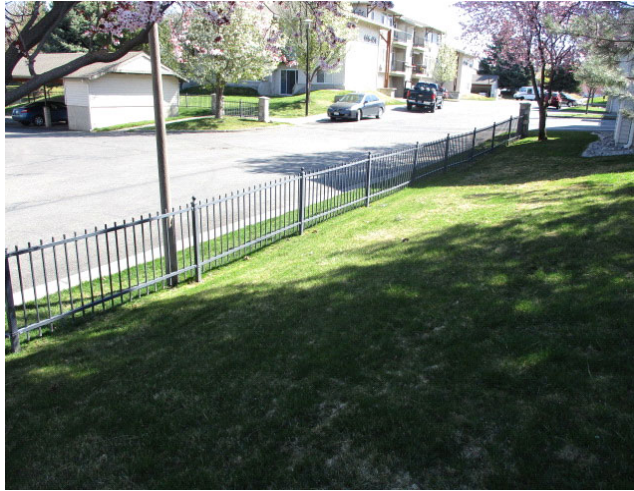
This is the metal fencing located throughout the community:

243 - lin. ft. of 5 ft. fence - pool area	@	\$49.00	=	\$11,907.00
1,675 - lin. ft. of 3 ft. fence - property line	@	\$40.00	=	\$67,000.00
		TOTAL	=	<u>\$78,907.00</u>

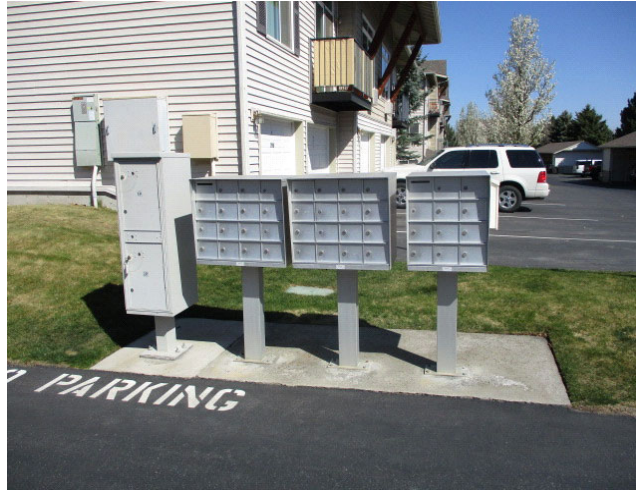
These are the pedestal metal mailbox sets located throughout the community:

10 - 16 box units	@	\$2,330.00	=	\$23,300.00
3 - 12 box units	@	\$2,220.00	=	\$6,660.00
		TOTAL	=	<u>\$29,960.00</u>

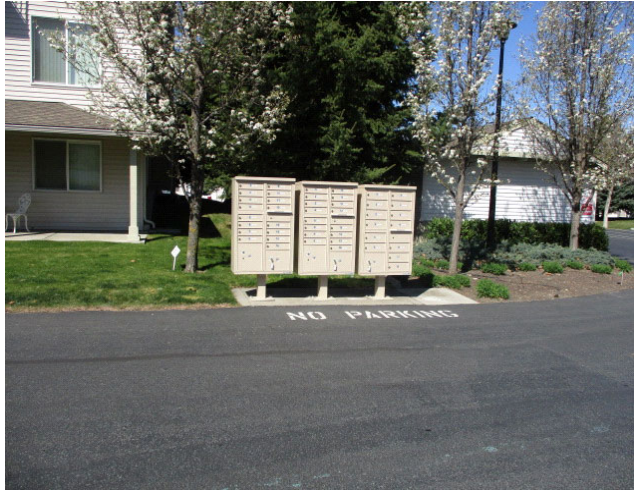
These are the 2020 pedestal metal mailbox sets located throughout the community:

2 - 16 box units	@	\$2,330.00	=	\$4,660.00
1 - 12 box units	@	\$2,220.00	=	\$2,220.00
		TOTAL	=	<u>\$6,880.00</u>

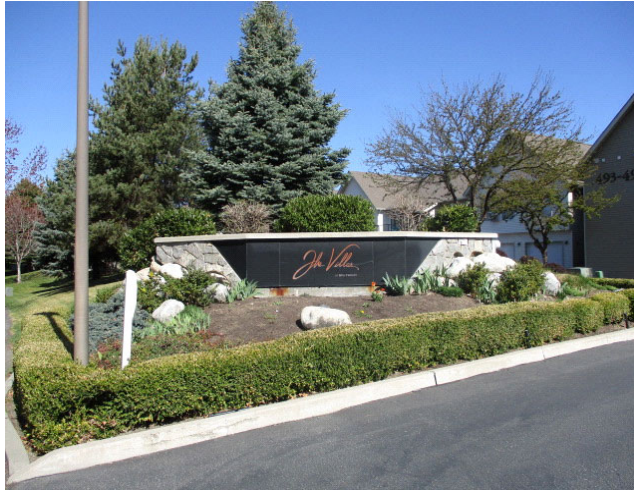
These are the various signs located throughout the community:

2	- entry monuments - refurbish	@	\$2,500.00	=	\$5,000.00
			TOTAL	=	\$5,000.00

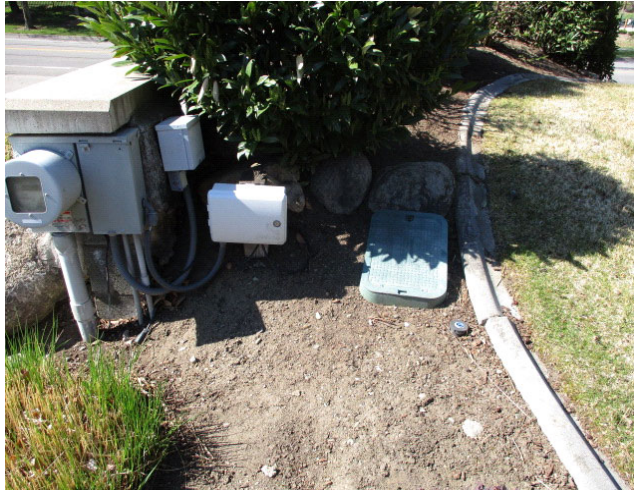
For the purposes of this analysis, we have budgeted for this equipment using general estimates based on our experience with similar equipment.

This includes, but is not limited to irrigation controllers, cabinets (if present), backflow valves, drainage intallations and infrastructure maintenance.

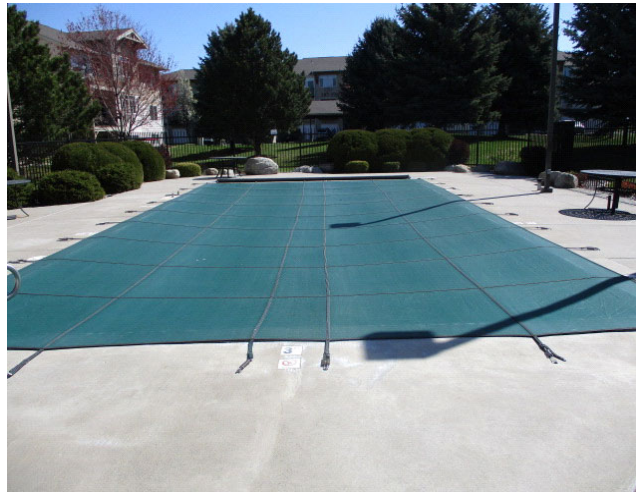
This is for the winter pool cover.

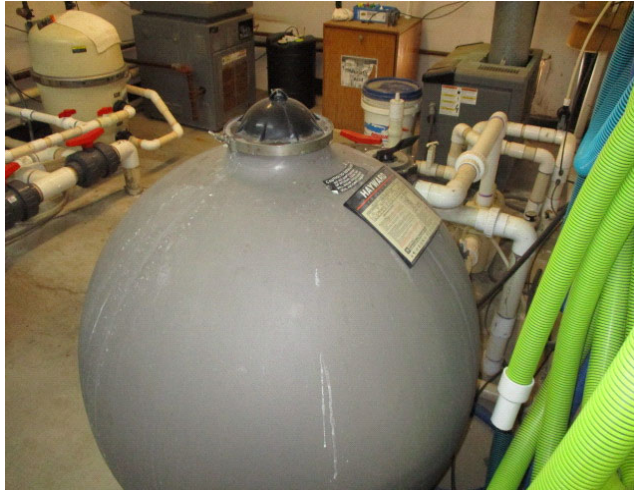
This is the Hayward Pro S360SX Sand Filter.

The association had the sand/gravel replaced in 2012 for a total of \$783.06

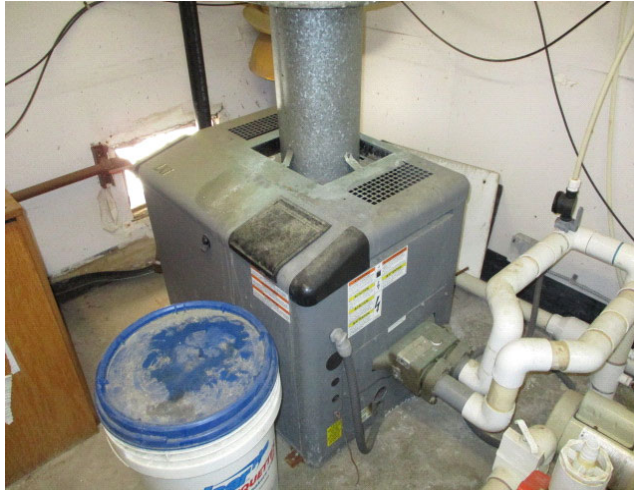
This is the Jandy LRZ400ENC 399,000 BTU pool heater.

The pool heater was replaced in 2012 at a cost of \$4,000.16.

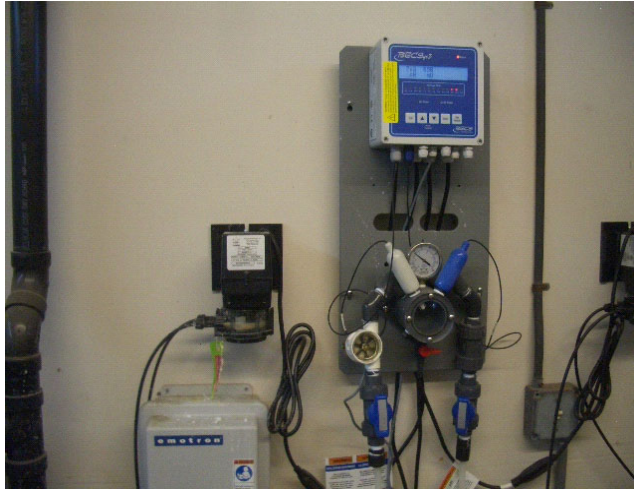
The association replaced the spa chemical controller in 2016 at a cost of \$4,208.00.

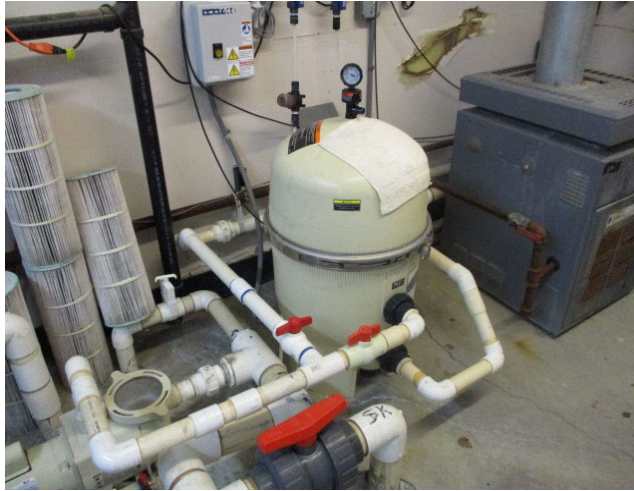
This is the Pentair CCP 320 spa filter.

The spa filter was replaced in 2012 at a cost of \$1,400.00.

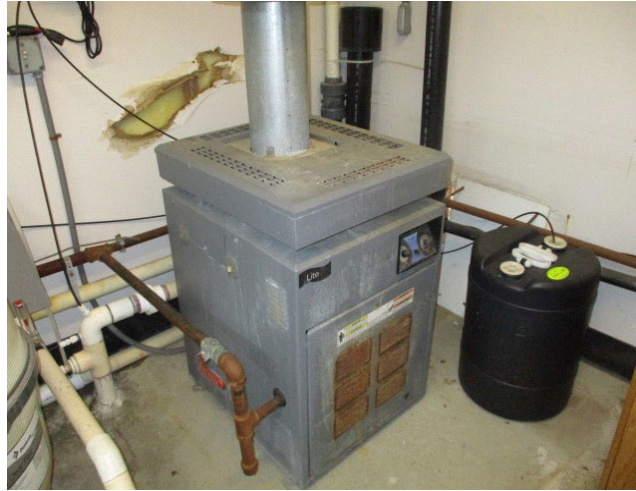
This is the Laars Lite 2 LD250NX spa heater.

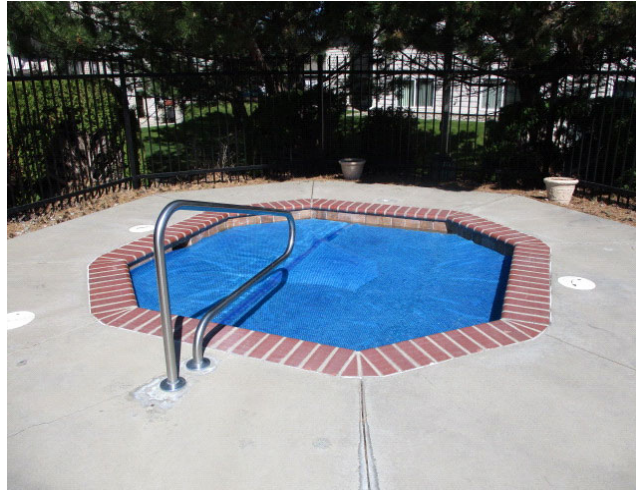
This is for the retile of the spa.

The tile and grout lines should be periodically inspected and any damaged grout lines refilled and sealed to help maintain the integrity of the component.

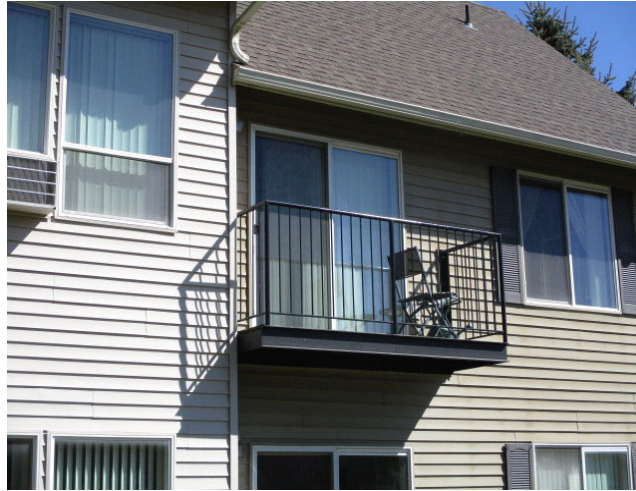
At our July 6, 2017 site visit many of the metal balconies need to be painted to protect the metal.

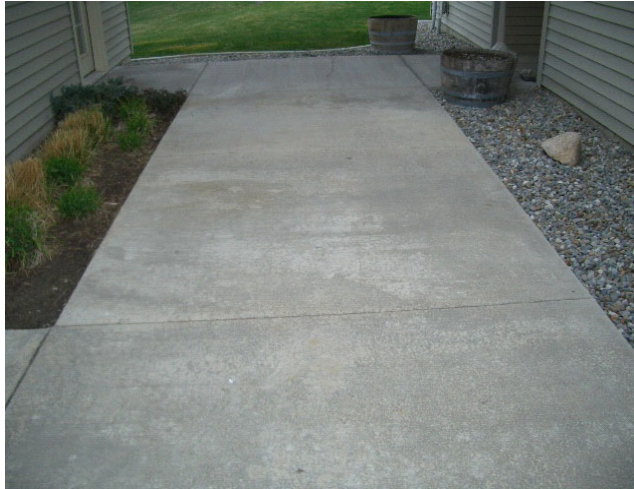
Please refer to our comments in the Consultant's Disclosure regarding unfunded components.

These are the typical sidewalks, curbs, and drainage swales located throughout the community.

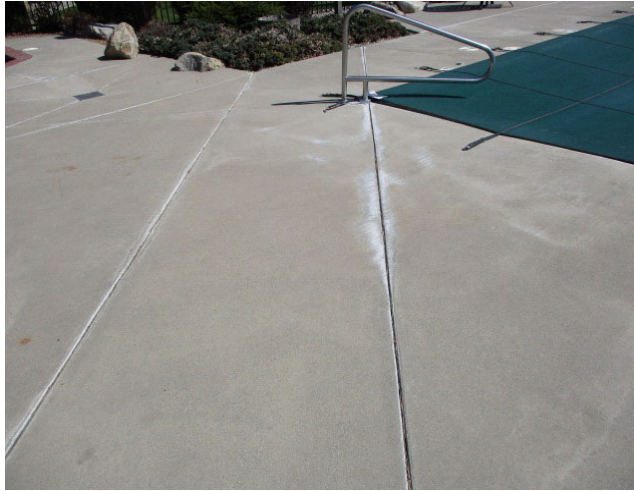
Category	100 Unfunded	Quantity	1 comment
Photo Date	April 21, 2021	Unit Cost	\$0.00
		% of Replacement	0.00%
		Current Cost	\$0.00
Placed In Service	01/98	Future Cost	\$0.00
Useful Life	n.a.		
		Assigned Reserves at FYB	\$0.00
Remaining Life	n.a.	Monthly Member Contribution	\$0.00
Replacement Year	n.a.	Monthly Interest Contribution	\$0.00
		Total Monthly Contribution	\$0.00

Typically, budgeting for concrete pool decks as a reserve component is excluded as it is anticipated that any repairs required will be addressed immediately due to safety concerns. Good maintenance practice would not allow the need for repairs to accumulate to a point that they would become a major expense. Minor repairs, as needed, should be addressed immediately as a maintenance issue using the client's operating and/or reserve contingency funds.

Please refer to our comments in the Consultant's Disclosure regarding unfunded components.

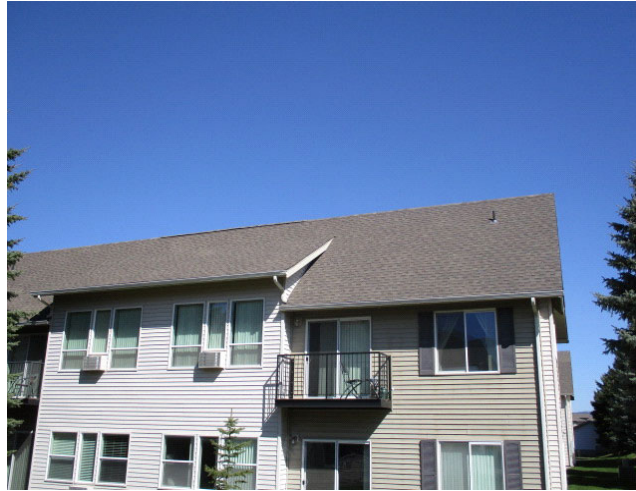
Windows are considered a Limited Common Area. Big Trout Condominiums Association CC&Rs Article 3 section 3.5. Repair and Maintenance states "to the extent that the Limited Common Elements are maintained by individual Unit Owners pursuant to Section 5.2
